ASCC 3-D Laser Scanning Study

Part 1: Eight participants used scanners to determine target coordinates

by William Paul, James Klinger, and Bruce A. Suprenant

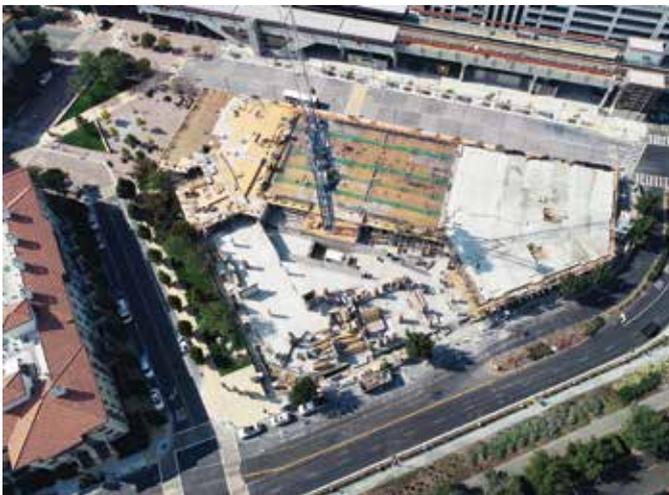
Fig. 1: The project site comprised a ground-level slab (lower left) and a podium level (right) (photo courtesy of BKF Engineers)

The construction project that served as the evaluation site is a hybrid concrete “podium” and wood-framed apartment structure commonly found in California, featuring a basement parking level approximately 10 ft (3.0 m) below grade, a mixed commercial/residential level (ground level), and an elevated residential level approximately 12 ft (3.7 m) above the ground floor (podium level). The podium level was designed to support five floors of wood-framed residential units. The ground and podium levels are post-tensioned elevated slabs supported by cast-in-place columns and shotcrete walls. Test areas at each level were about 6000 ft² (about 560 m²).

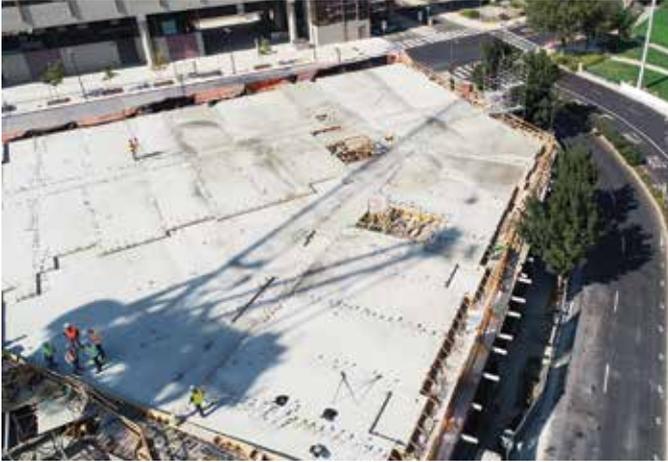
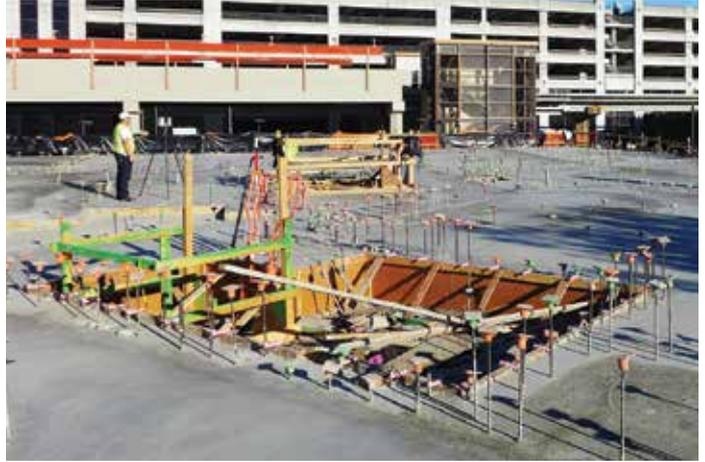
Fig. 2: The podium-level slab included many protruding anchor rods (aerial photo courtesy of BKF Engineers)

Because the podium slab is the foundation for the wood-framed structure above, it includes many protruding anchor rods for the framed structure’s shear walls and sill plates. As can be expected in residential construction, the slab also contains many sleeves, conduit stub-ups, and similar discontinuities (Fig. 2).

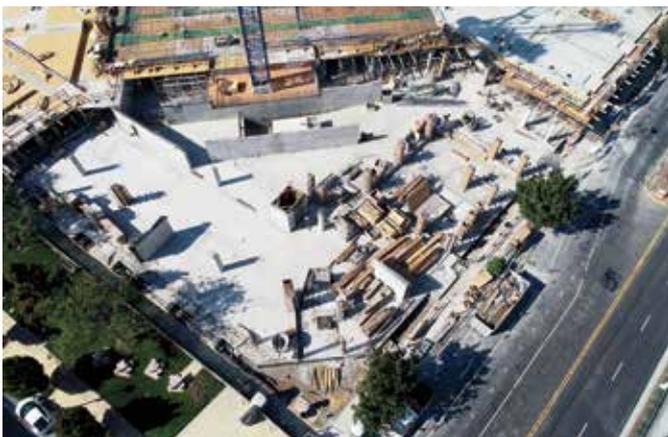
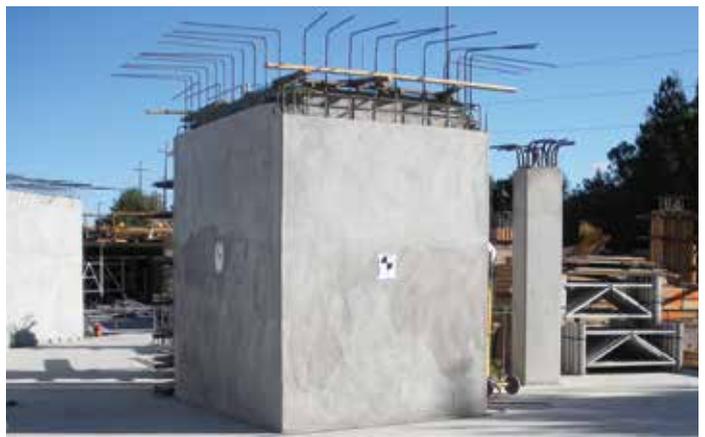
Fig. 3: Ten targets were placed at various locations on vertical surfaces (concrete walls and columns at the ground level) for participants to determine their point coordinates. The reference target point coordinates were obtained using a total station at three locations. Ten targets were also placed at various locations on the horizontal concrete surface at the podium level (aerial photo courtesy of BKF Engineers)

Fourteen targets were placed on both the ground- and podium-level slabs. All targets on the podium level were placed on the concrete slab surface. On the ground level, 10 targets were placed on concrete walls (Fig. 3) and columns and four targets were placed on the slab surface. The targets were located such that multiple laser setups would have to be used to obtain a line of sight. This was done to ensure that the participants had to stitch together (register) the individual scans in three dimensions to create a larger, contiguous point cloud. For analysis, all 14 targets were surveyed with a total station from three separate locations to provide the “reference” coordinates. Coordinates for four targets on each level were provided to the participants for control points.

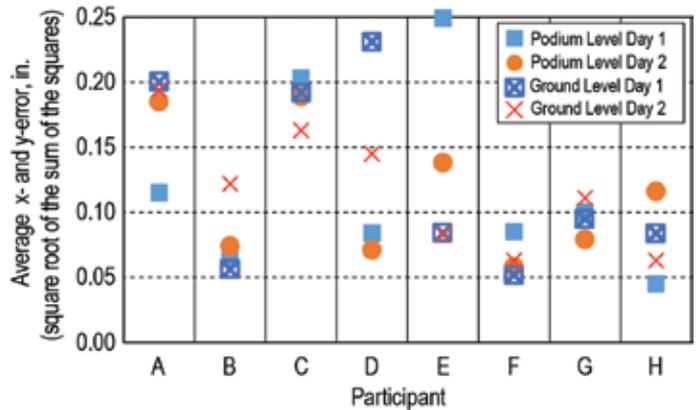
Fig. 4: The average SRSS x-y error for each laser participant varied as shown. Participants B, F, G, and H had SRSS x-y errors less than 0.15 in. (4 mm) and good repeatability of the four scans (Note: 1 in. = 25 mm)

Figure 4 shows the average SRSS errors (calculated using x- and y-coordinates) for the 10 targets on both the podium and ground levels for each of the two scans (Days 1 and 2). For all four scans, SRSS error ranges found for Participants C, F, and G were under about 0.05 in. (1.3 mm), while SRSS error ranges found for Participants A, B, and H were under 0.10 in. (2.5 mm). The largest SRSS error ranges were for Participants D and E, with values of about 0.20 in. (5 mm). An SRSS error of 0.20 in. would be an error of 0.14 in. (3.5 mm) in both the x and y directions. Figure 4 also shows that the repeatability of laser scans was very good for most participants. However, the SRSS error range between repeated measurements for Participants D and E was about 0.15 in. (3.5 mm).

As noted previously, the 10 targets at ground level were placed on vertical elements and the 10 targets on the podium level were all placed on the horizontal concrete surface. The SRSS errors and SD values for each level were essentially the same, with average SRSS errors of 0.121 in. (3.1 mm) on the ground level and 0.116 in. (2.9 mm) on the podium level. The corresponding SD values were 0.068 in. (1.7 mm) on the ground level and 0.087 in. (2.2 mm) on the podium level.

The maximum error can be found in Tables 2 and 3. Participants B, F, G, and H had maximum SRSS errors of less than 0.30 in. (7.5 mm); Participant C had a maximum SRSS error of less than 0.50 in. (12.5 mm); Participant A had a maximum error of 0.75 in. (19 mm); and Participant D had an error that exceeded 1 in. (25 mm).

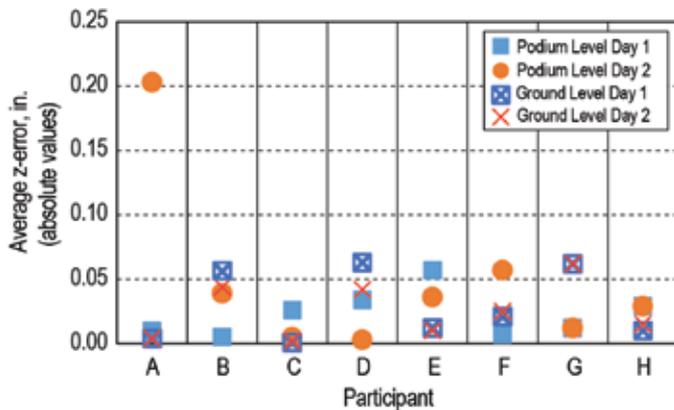
Fig. 5: Except for laser participant A, the z-errors were below 0.06 in (1.5 mm) and showed good repeatability for both the ground and podium levels (Note: 1 in. = 25 mm)

Figure 5 shows the average z-error for the 10 targets on the ground and podium levels. The average z-error was very consistent at 0.06 in. (1.5 mm) or below, except for Participant A. Although the maximum z-error for Participant A was 0.20 in., it appears that the high error is an outlier—the other three z-errors found for Participant A were all less than

0.02 in. (0.5 mm). The repeatability between measurements was also very good except for Participant A.

The average z-errors were 0.008 in. (0.2 mm) on the ground level and 0.027 in. (0.7 mm) on the podium level, and the average SDs were 0.086 in. (2.2 mm) on the ground level and 0.048 in. (1.2 mm) on the podium level.

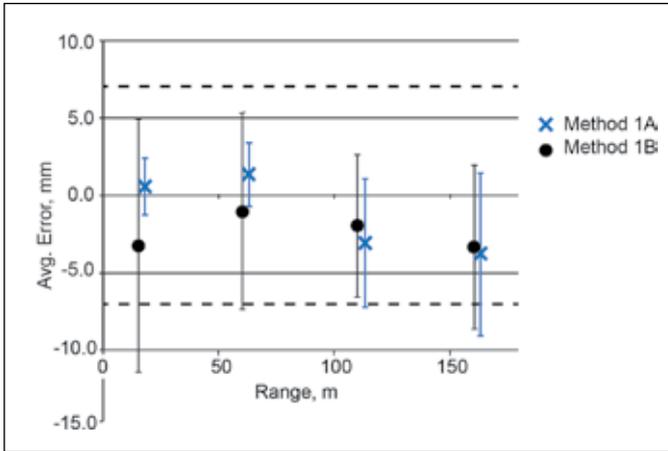
Fig. 6: Error versus range (based on Ref. 2, Fig. 21). Points represent the averages for a given range over all reflectivities, angles of incidence, and azimuths. There were no data for the 2% reflective target for ranges greater than 60 m (197 ft). The error bars are the SDs of the data (Note: Range values for the two data sets have equal values but are plotted with a slight offset for clarity; 1 mm = 0.04 in.; 1 m = 3.3 ft)

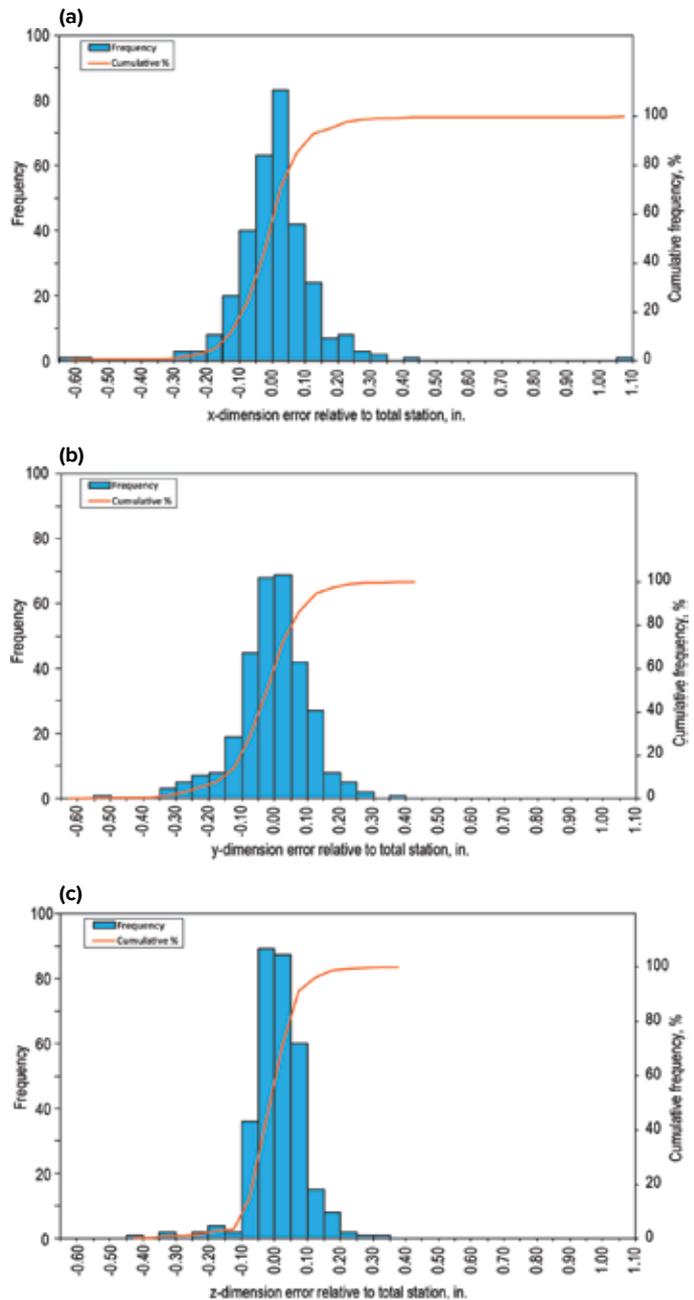
Fig. 7: Histograms showing the error relative to measurements taken using a total station for 310 points measured by participants using laser scanners: (a) error in x-dimension; (b) error in y-dimension; and (c) error in z (vertical) direction

For laser scanning, Fig. 7 illustrates the errors determined in this study. Tables 4, 5, and 6 provide the target error

analysis based on the data for the ground and podium levels and on all 310 individual target measurements. Based on the data in this study, our analyses indicate that it would be appropriate to use a laser scanner for specification compliance when measuring a vertical tolerance of 5/8 in. (15.9 mm) or more and a horizontal tolerance of 1 in. or more.

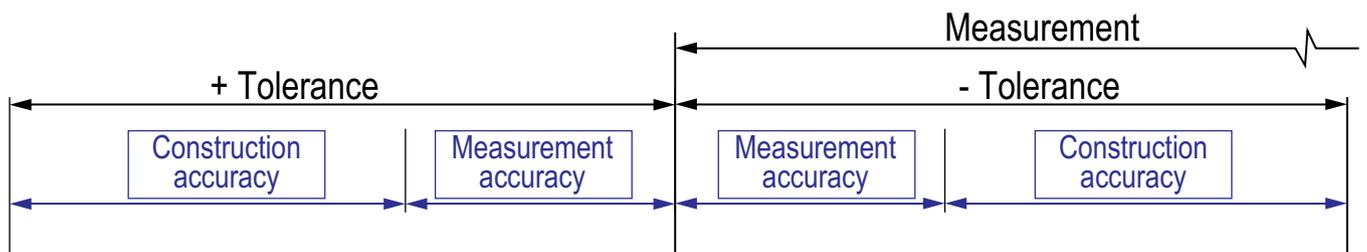
A specified tolerance includes a measurement accuracy and a construction accuracy

ACI 117-10* defines a tolerance as the permitted deviation from a specified value. To determine if an as-built concrete structure meets the specified deviation, a measurement must be made. Thus, the accuracy of the measuring device is a part of the overall tolerance, as the overall tolerance includes both a measurement part and a construction part (as shown in the figure).
